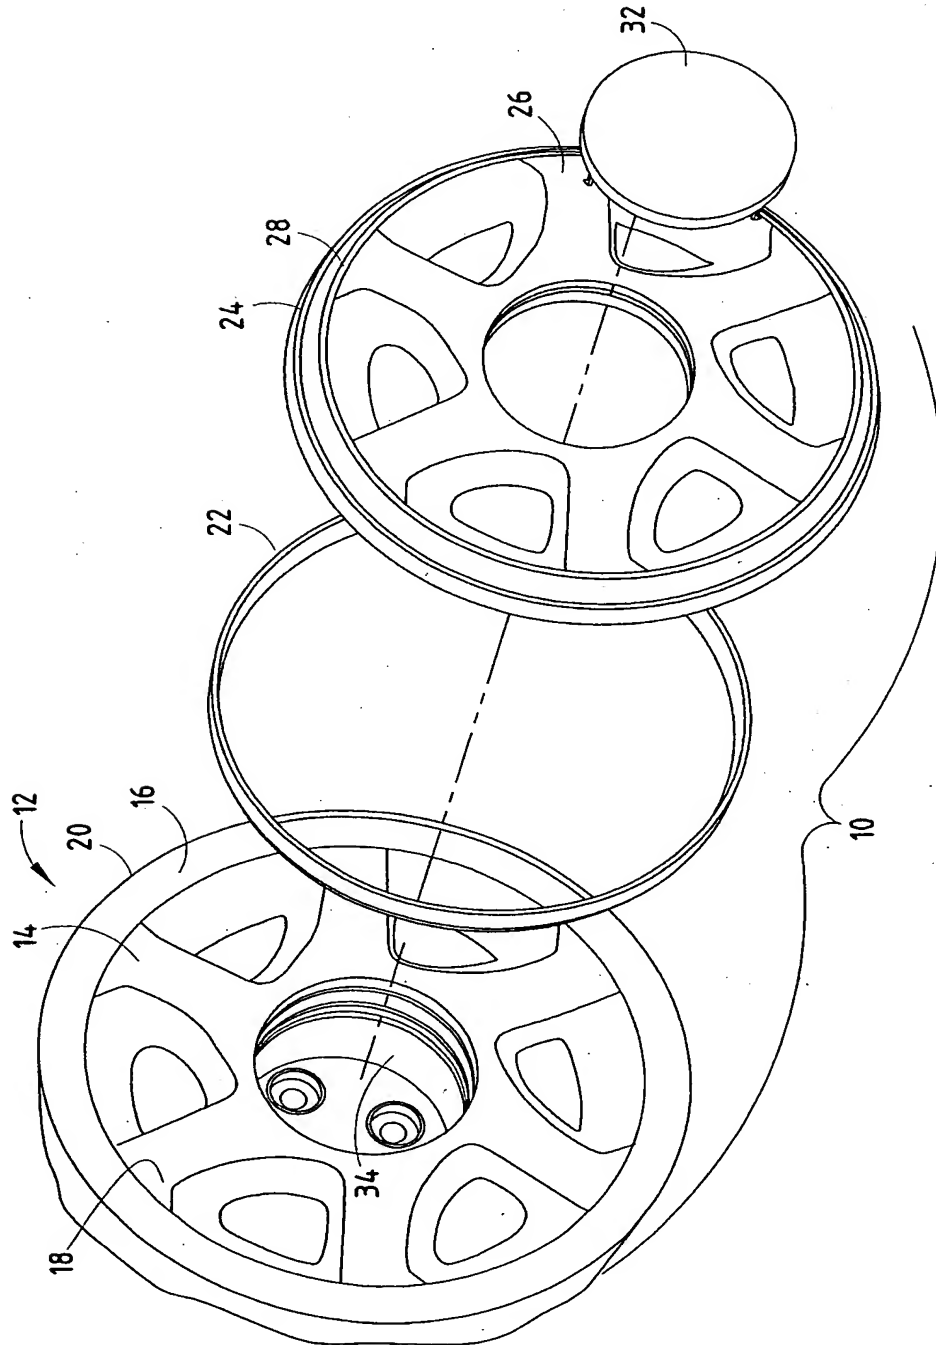
FIG. 1 is a top-down view of a circular wheel assembly 10. The assembly includes a central hub 32, six spokes 34, and a rim 26. The rim features a tread pattern 28 and a groove 12. A cross-section line III-III is indicated on the left side of the rim.
